# PHASE I ENVIRONMENTAL SITE ASSESSMENT REPORT

## **Vacant Land**

1032 Dolsontown Road Middletown, New York 10940

Report Date: December 31, 2020 Partner Project No. 20-302774.1

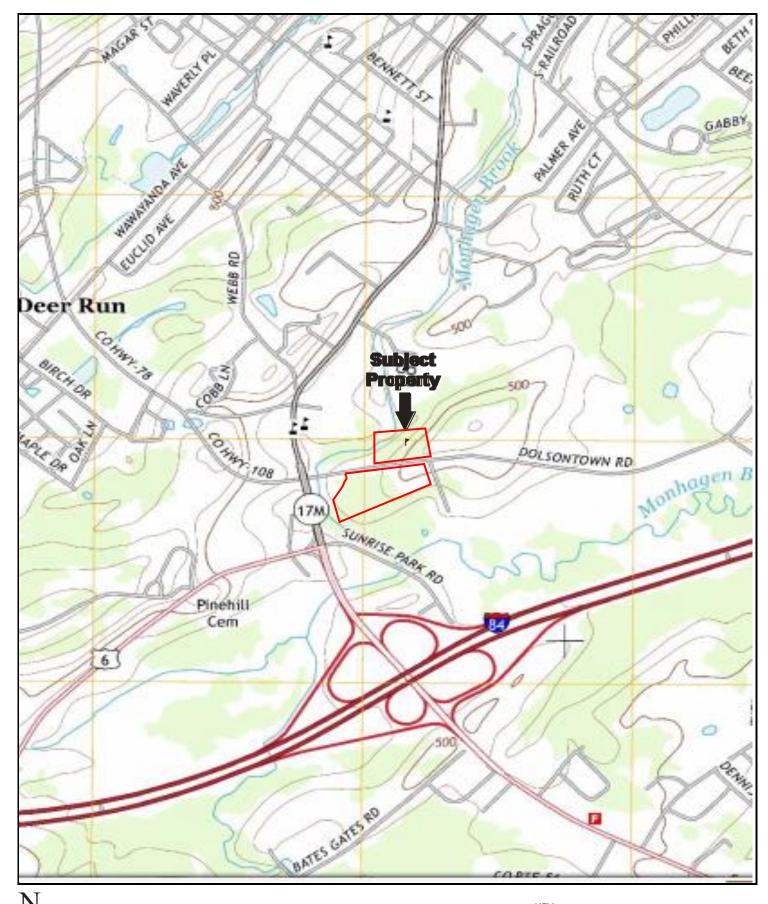
USGS 7.5 Minute Middletown, New York Quadrangle Created: 2013

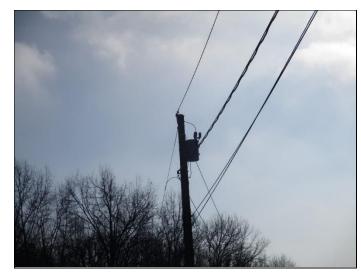
One (1) pole-mounted transformer was observed on the adjacent properties. No staining or leakage was observed in the vicinity of the transformer. Based on these observations, the presence of adjacent transformers is not expected to represent a significant environmental concern.

16. Pole-mounted transformer

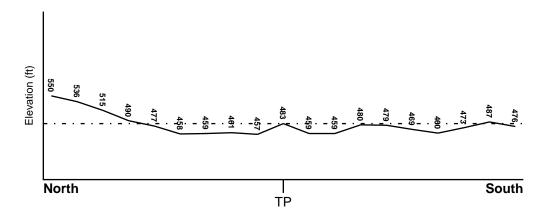
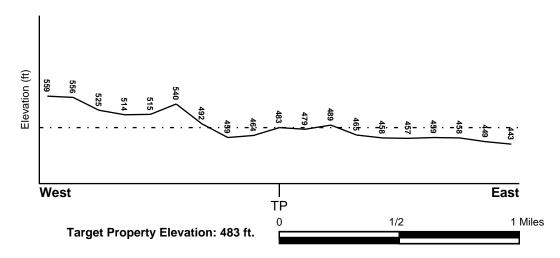
#### SURROUNDING TOPOGRAPHY: ELEVATION PROFILES

Source: Topography has been determined from the USGS 7.5' Digital Elevation Model and should be evaluated on a relative (not an absolute) basis. Relative elevation information between sites of close proximity should be field verified.
